**Flood Control Project Maintenance
Levee Inspections**

Maintenance Issue Types Only, Levee Inspection Report By Mile - Spring 2019

Reclamation District No. 1600 Mull

Waterway	Bank	Unit Miles	Inspection Start/End	Inspector
Unit No. 01 Sacramento River	Right	10.46	03/05/2019 03/07/2019	Zach Jojola

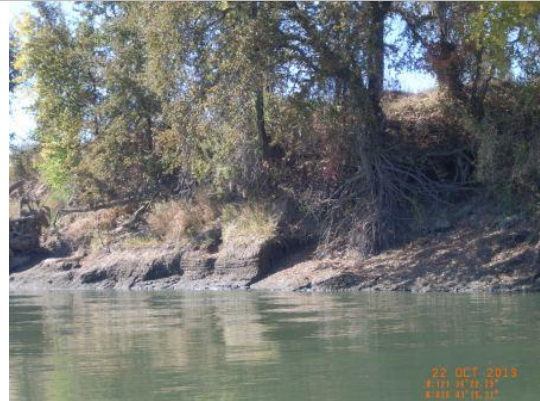
Photo 1 of 1 : SP_2019_RD1600_191_16_20190304_00004.jpg

Comment Code					
Inspector Comment					
2017 Site ID: SAC 74.4 R Status: Eroding 2017 Field Notes: Significant erosion at toe in the past year. Fresh tree popout. Site History: 1997 - Steep high bank. 2005 - Some small pockets in the low toe near the waterline. 2006 - Minor slope clearing. 2010 - Minor new erosion. 2011 - Multiple trees have fallen since last year. Some other trees look ready to fall. Significant new erosion since last year. 2012 - Minor new erosion. 2013 - Minor new erosion. 2015 - Minor new toe erosion. DWR Inspector Comment: Erosion within waterside bench and possibly sections of the waterside toe prism.

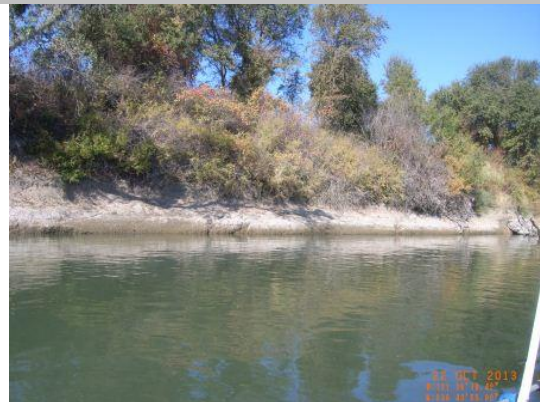
Photo 1 of 1 : SP_2019_RD1600_191_17_20190304_00005.jpg

LM Start	4.34	Rating **	M	Issue No.	17
LM End	4.86	Issue Type +	Ma	Location *	WS
Category	Supplemental			GPS Latitude/Longitude	
				Start	End
Item	2017 USACE Erosion Survey, DRAFT			38.728684 °	38.736110 °
				-121.605844 °	-121.604153 °
DWR ID	DWR_RD1600_01_f_2018_17				
Comment Code					
Inspector Comment					
2017 Site ID: SAC 75.3 R					
Status: Eroding					
2017 Field Notes: Fresh erosion along lower bank in sections.					
Site History: 1997 - Very steep bank. 2005 - Lots of small trees down along the bank at the upstream end. 2006 - Minor new erosion, but slow. 2010 - Almost all of the roots are exposed on the trees, appears ready to fall. 2011 - New erosion and tree popouts. 2012 - Site has become overgrown with vegetation, making it hard to observe. 2015 - Dense vegetation made the site difficult to observe.

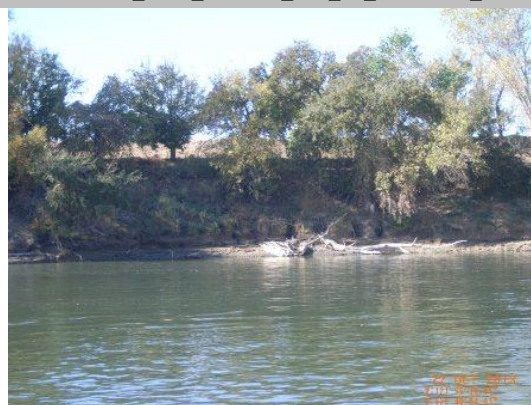
Photo 1 of 1 : SP_2019_RD1600_191_23_20190304_00013.jpg

LM Start	6.95	Rating **	M	Issue No.	23
LM End	6.98	Issue Type +	Ma	Location *	WS
Category	Supplemental			GPS Latitude/Longitude	
				Start	End
Item	2017 USACE Erosion Survey, DRAFT			38.764801 °	38.765219 °
				-121.594926 °	-121.595049 °
DWR ID	DWR_RD1600_01_f _ 2018_23				
Comment Code					
Inspector Comment					
2017 Site ID: SAC 77.7 R					
Status: Eroding					
2017 Field Notes: Minor new erosion.					
Site History: 2006 - Eddy scour off end of rock causing erosion and scour hole near levee. Sandy silt bank with rock on upstream end.					
2010 - Trees are leaning more, minor new erosion. 2011 - Many of the tree roots have scoured out and trees look ready to fall.					
DWR Inspector Comment: Continued erosion within the waterside berm.

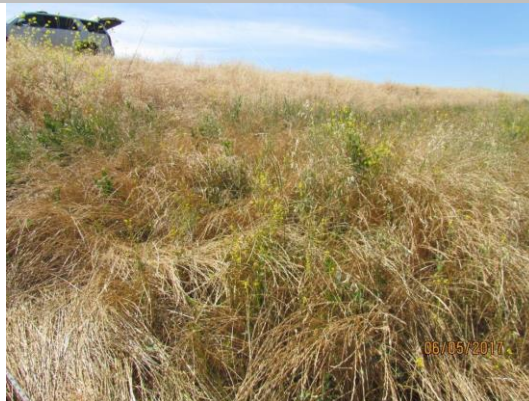
Photo 1 of 3 : LEVAL_SP_2019_202_1210.jpg

LM Start	1.79	Rating **	M	Issue No.	17
LM End	2.27	Issue Type +	Ma	Location *	
Category	Supplemental			GPS Latitude/Longitude	
				Start	End
Item	2017 Storm Damage			38.710763 °	38.704121 °
				-121.637147 °	-121.639992 °
DWR ID	DWR_RD1600_02_f_2017_17				
Comment Code					
Inspector Comment					
Levee Evaluation Comments					
Description:					
Site ID No:202					
Site Designation:RD 1600-01					
Repair Type: Erosion					
Rating:Area of Concern					
Field Date:6/5/2017					
Notes: Long streches of wavewash on the waterside slope.

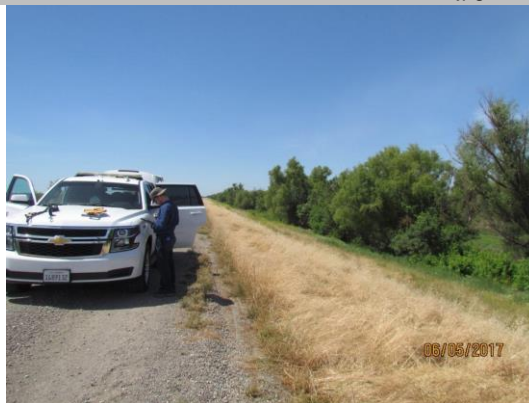
Photo 3 of 3 : LEVAL_SP_2019_202_371.jpg

LM Start	1.79	Rating **	M	Issue No.	17 (cont)	
LM End	2.27	Issue Type +	Ma	Location *		
Category	Supplemental			GPS Latitude/Longitude		
				Start		End
Item	2017 Storm Damage			38.710763 °	38.704121 °	
				-121.637147 °	-121.639992 °	
DWR ID	DWR_RD1600_02_f_2017_17					
Comment Code						
Inspector Comment						
Levee Evaluation Comments						
Description:						
Site ID No:202						
Site Designation:RD 1600-01						
Repair Type: Erosion						
Rating:Area of Concern						
Field Date:6/5/2017						
Notes: Long streches of wavewash on the waterside slope.
